**TOTAL MAXIMUM DAILY LOAD (TMDL)**  
**For**  
**Siltation and Habitat Alteration**  
**In The**  
**Upper Duck River Watershed (HUC 06040002)**  
**Bedford, Coffee, Franklin, Giles, Lincoln, Marshall, Maury,**  
**Moore, Rutherford, and Williamson Counties, Tennessee**

**FINAL**

Tennessee Department of Environment and Conservation  
Division of Water Pollution Control  
6<sup>th</sup> Floor L & C Tower  
401 Church Street  
Nashville, TN 37243-1534

July 24, 2006

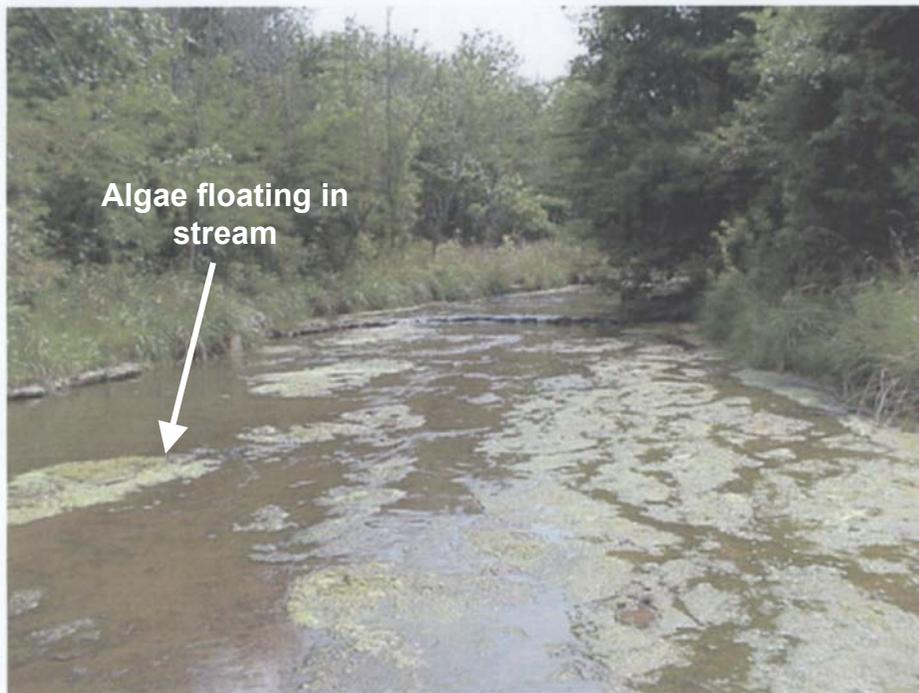
Figure D-8 Photo of Hurricane Creek upstream of sample site, RM 0.2 - July 18, 2001

Hurricane Creek (HURRI000.2MY) upstream view.  
Site located 100 yds upstream of old Hwy 50.  
PAA/CAP, 07/18/01.

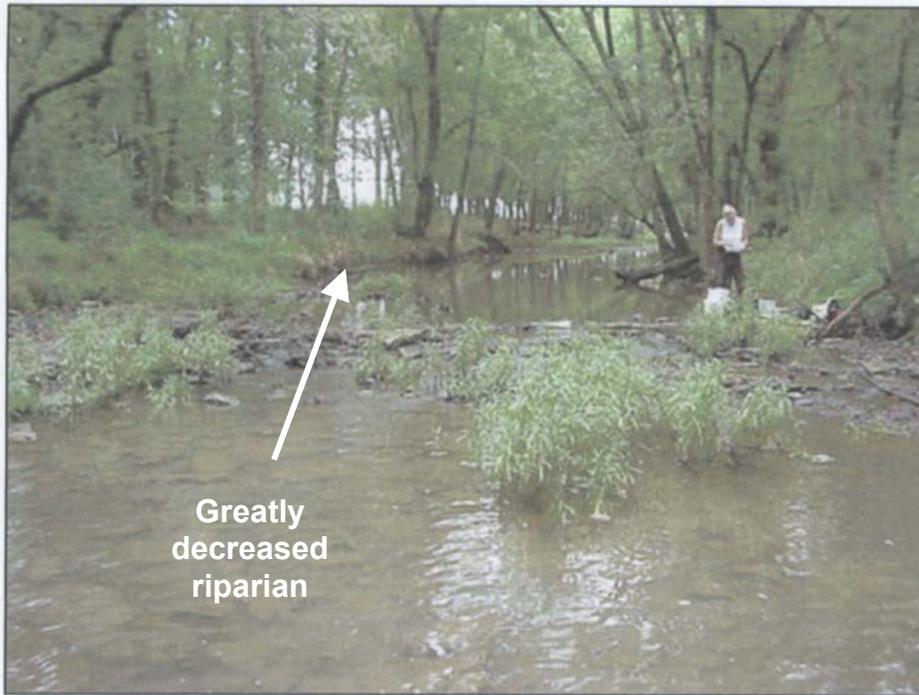
Figure D-17 Photo of Fall Creek, RM 6.1 - September 11, 2001

Fall Creek (FALL006.1BE) off Pinkston Rd.  
View upstream of the collection area. Collected  
9/10/01 @ 0920, KJS/SJB.

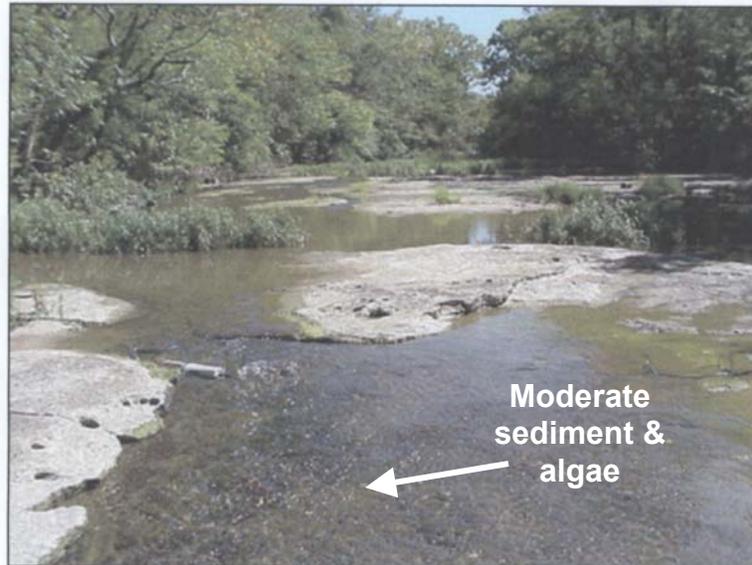
Figure D-20 Photo of Fall Creek Habitat Assessment, RM 1.2 - September 11, 2001

Fall Creek (FALL001.2BE) 100 yards u/s Hwy 41A.  
View u/s of the sampling area. Collected 9/11/01  
@ 1115, KJS/SJB.

Fall Creek was monitored at RM 1.1 in 1999 by the Nashville Environmental Field Office. Notes report very low flow, moderate bank erosion, algae choking the stream, and cows alongside the stream (ref.: Figures D-9 through D-12). Fall Creek was also monitored at RM 6.1 in 2001 by aquatic biologists from the State Lab. They noted moderate sedimentation and siltation, marginal vegetative protection and a greatly decreased riparian zone (ref.: Figures D-13 through D-17). Monitoring conducted the next day at RM 1.2 showed moderate sediment and algae and slight siltation in the stream (ref.: Figures D-18 through D-20).

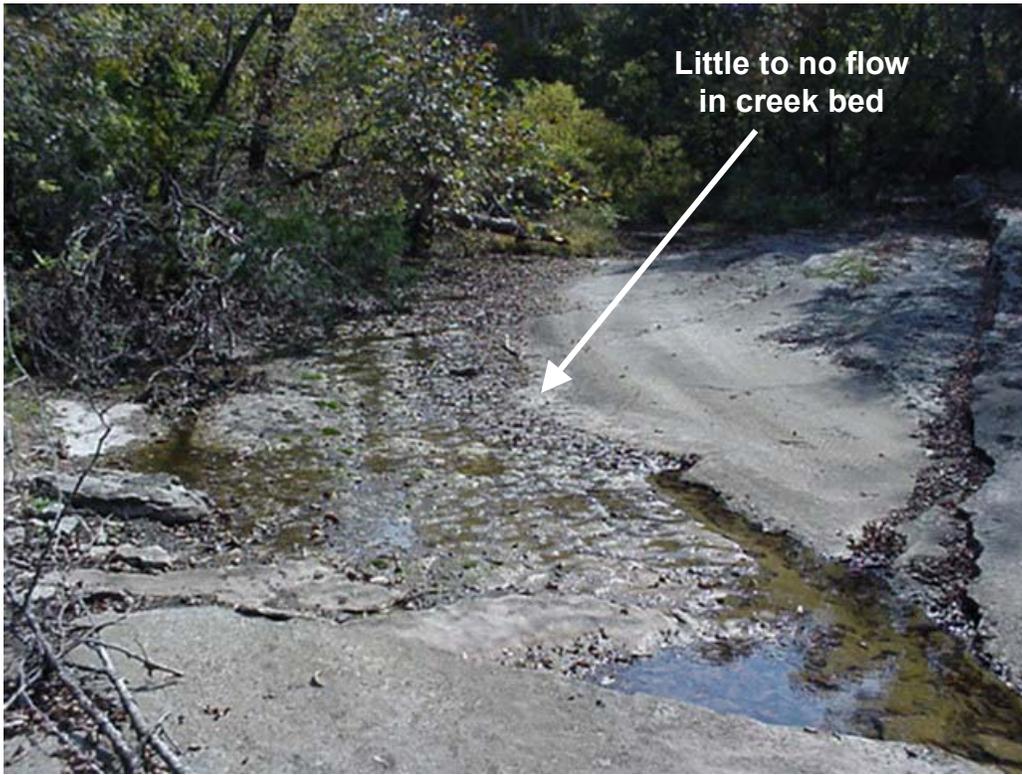
Figure D-27 Photo of Sinking Creek upstream - October 16, 2000

Little to no flow  
in creek bed

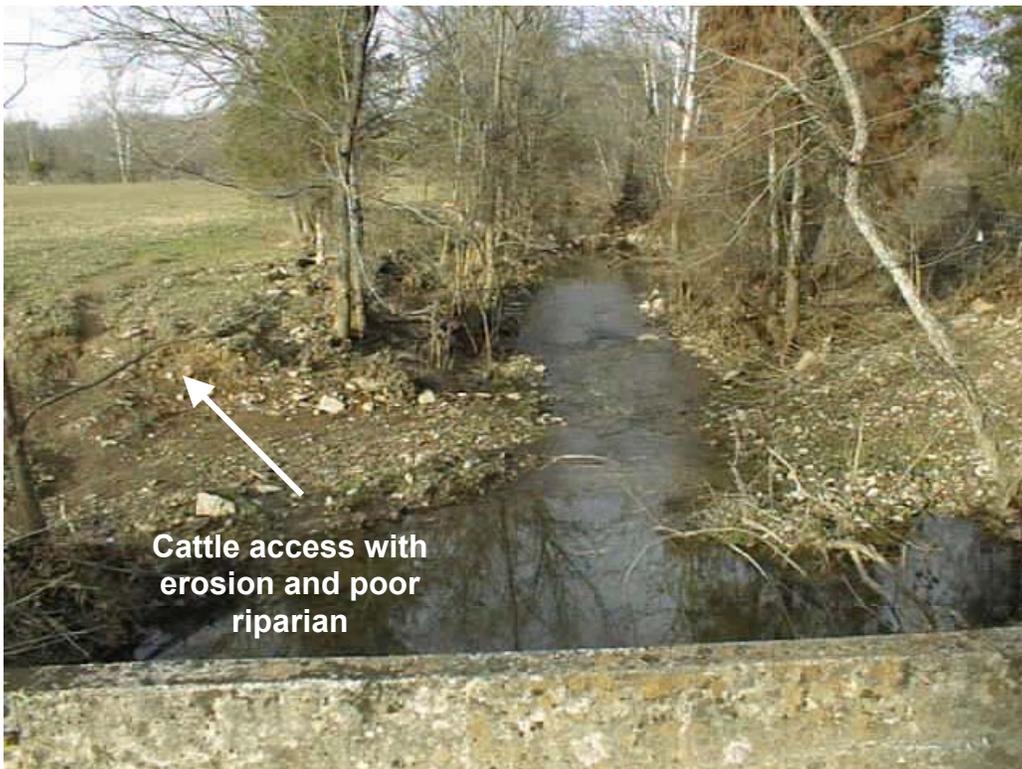
Figure D-28 Photo of Little Sinking Creek upstream - December 12, 1999

Cattle access with  
erosion and poor  
riparian

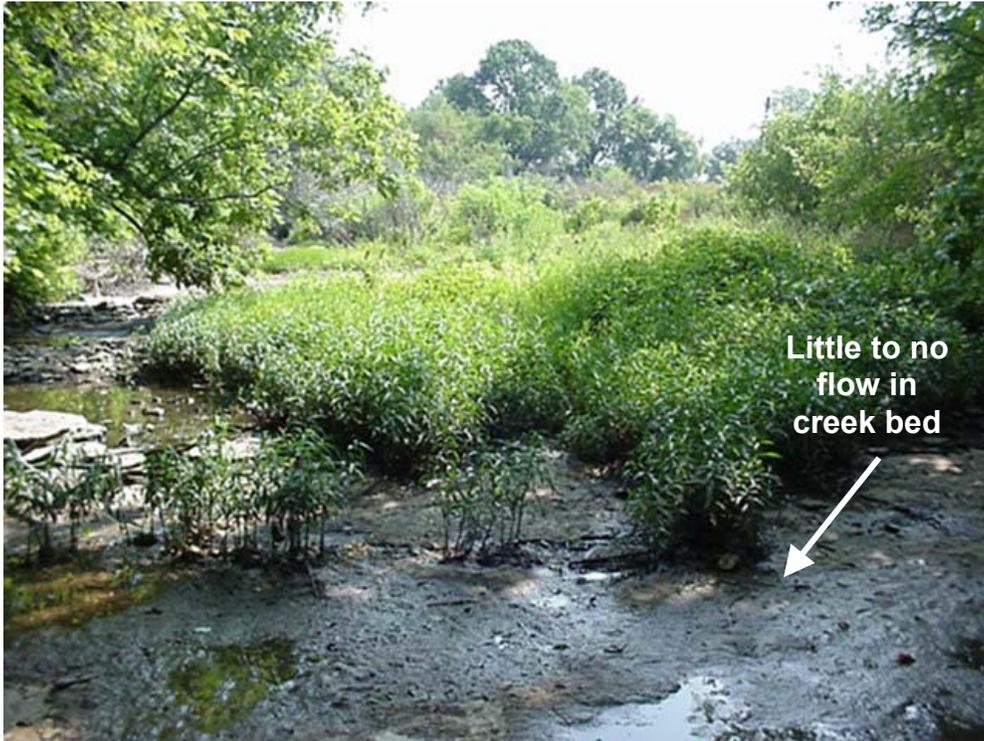
North Fork Creek was monitored at RM 7.7 and 16.4 by aquatic biologists from the State Lab on as a site of the probabilistic monitoring study. The stream at RM 7.7 was found have very low flow or dry on July 24, 2000 and October 17, 2000 (ref.: Figures D-34 through D-36). It contained flow on February 1, 2000, April 17, 2000, and again on May 8, 2001. All three sampling events noted slight to moderate siltation. Land use upstream was mostly pasture with cattle.

Figure D-34 Photo of North Fork Creek RM 7.7 upstream low flow - July 24, 2000

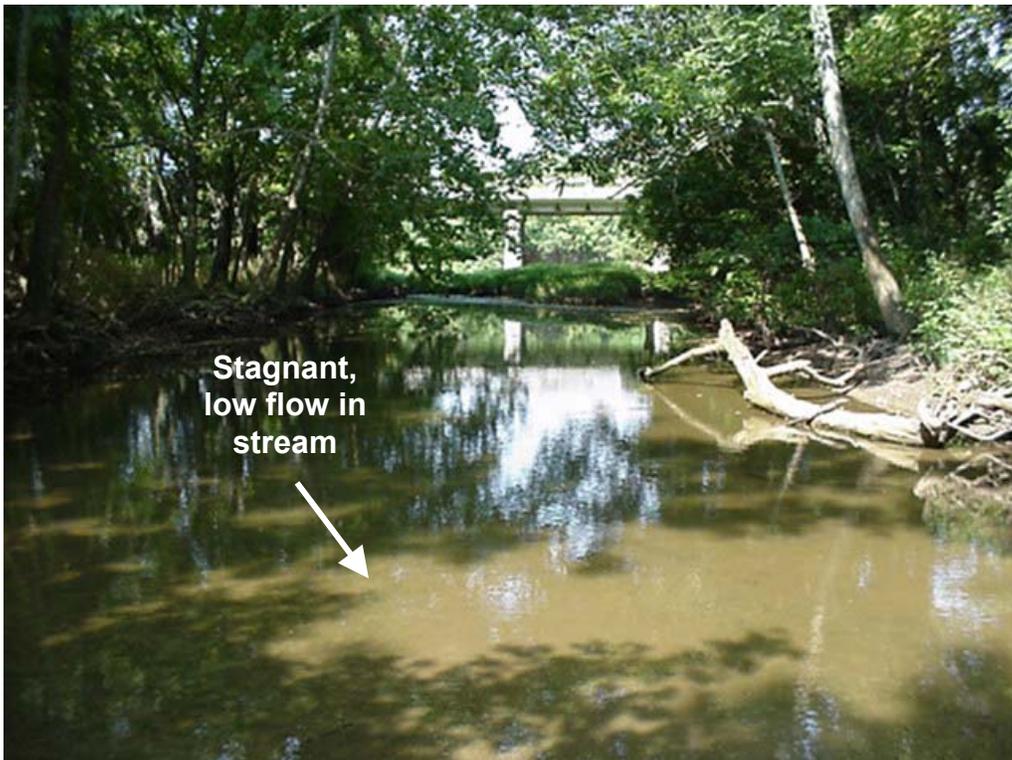
Figure D-35 Photo of North Fork Creek RM 7.7 downstream stagnant low flow - July 24, 2000

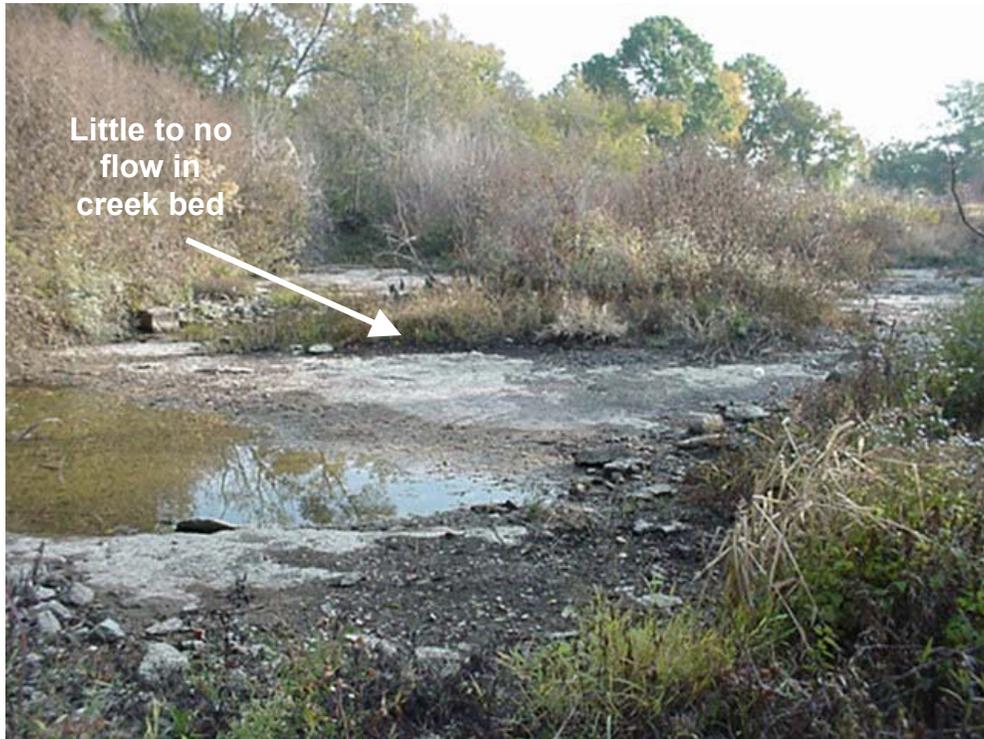
Figure D-36 Photo of North Fork Creek RM 7.7 upstream dry - October 17, 2000

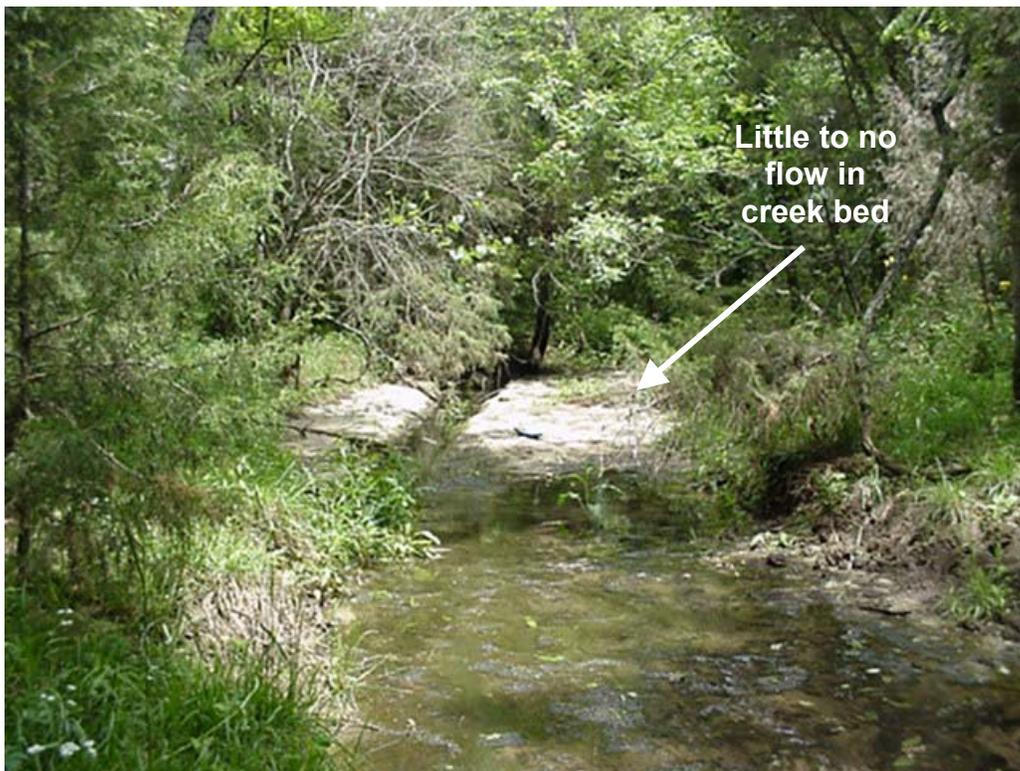
Figure D-39 Photo of North Fork Creek RM 16.4 upstream - May 10, 2000

North Fork creek at RM 16.4 was found to have very low flow or dry on July 25, 2000 and October 16, 2000 (ref.: Figures D-37 and D-38). It contained flow on January 11, 2000, April 19, 2000, and again on May 10, 2001 (ref.: Figure D-38). All three sampling events noted moderate siltation. Land use upstream was mostly pasture with cattle.

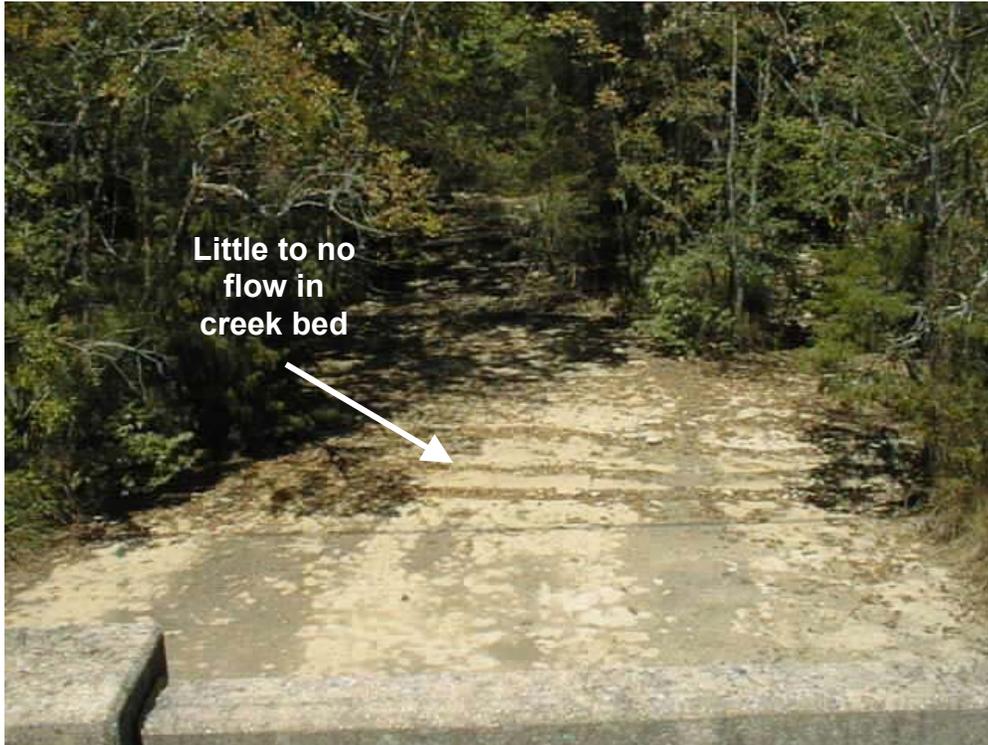
Alexander Creek was visited by staff from the Nashville Environmental Field Office on August 18, 1999 and observed to be dry (ref.: Figures D-40 through D-42).

Figure D-41 Photo of Alexander Creek RM 0.8 Upstream - August 18, 1999

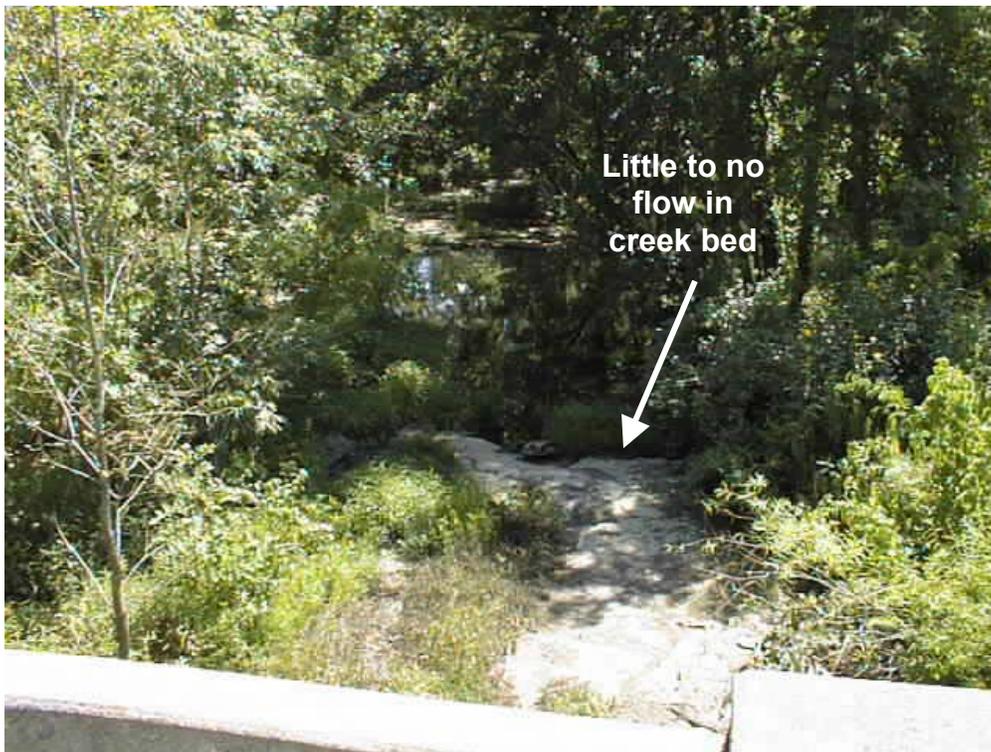
Figure D-42 Photo of Alexander Creek RM 0.8 Downstream - August 18, 1999

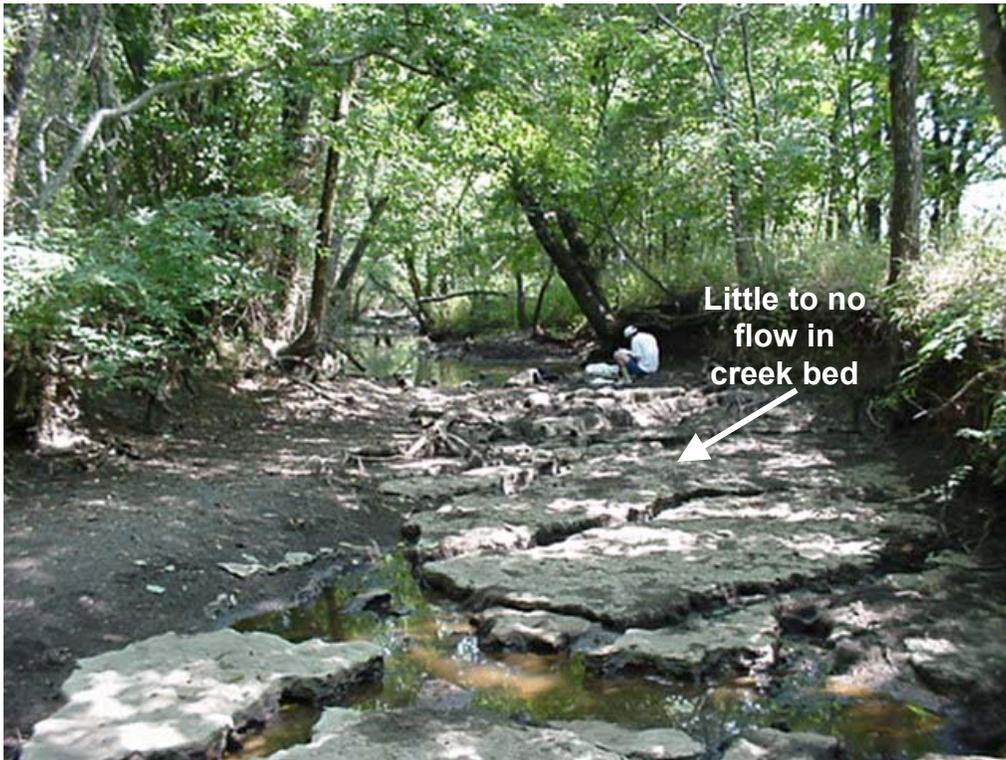
Alexander Creek was revisited by aquatic biologists from the State Lab on July 24, 2000, October 17, 2000, and on September 12, 2001 and was observed to be dry (ref.: Figures D-43 through D-45). Aquatic biologists from the State Lab monitored the site on January 10, 2000, April 13, 2000, and May 10, 2001 when flow was present (ref.: Figure D-46).

Figure D-43 Photo of Alexander Creek RM 4.0 Upstream - July 24, 2000

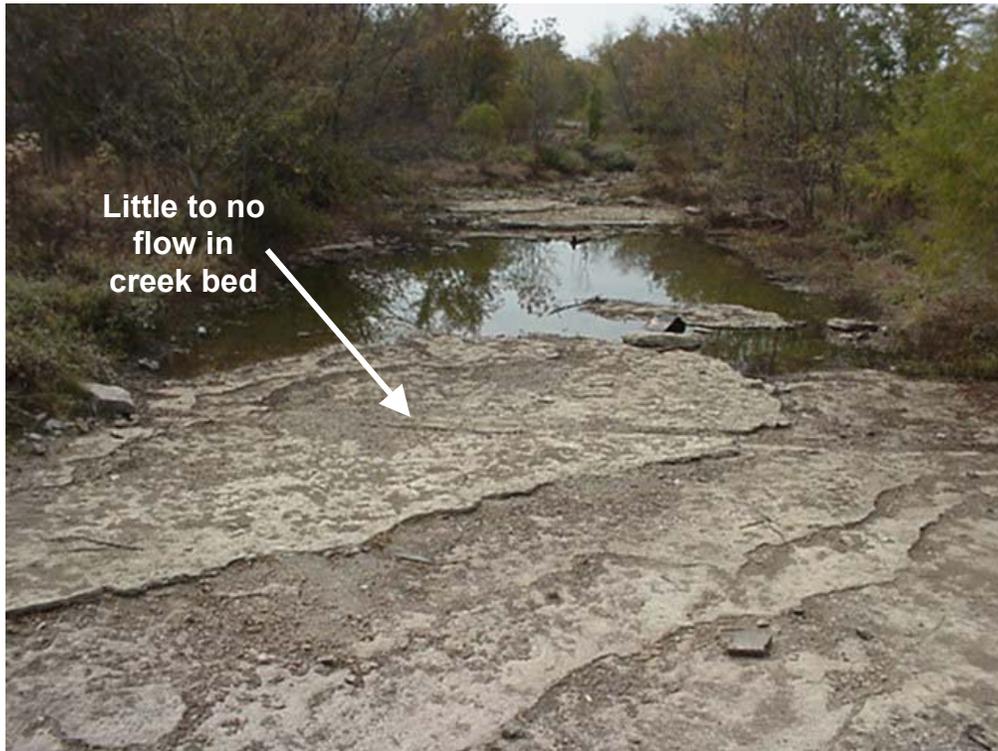
Figure D-45 Photo of Alexander Creek RM 0.4 - October 17, 2000

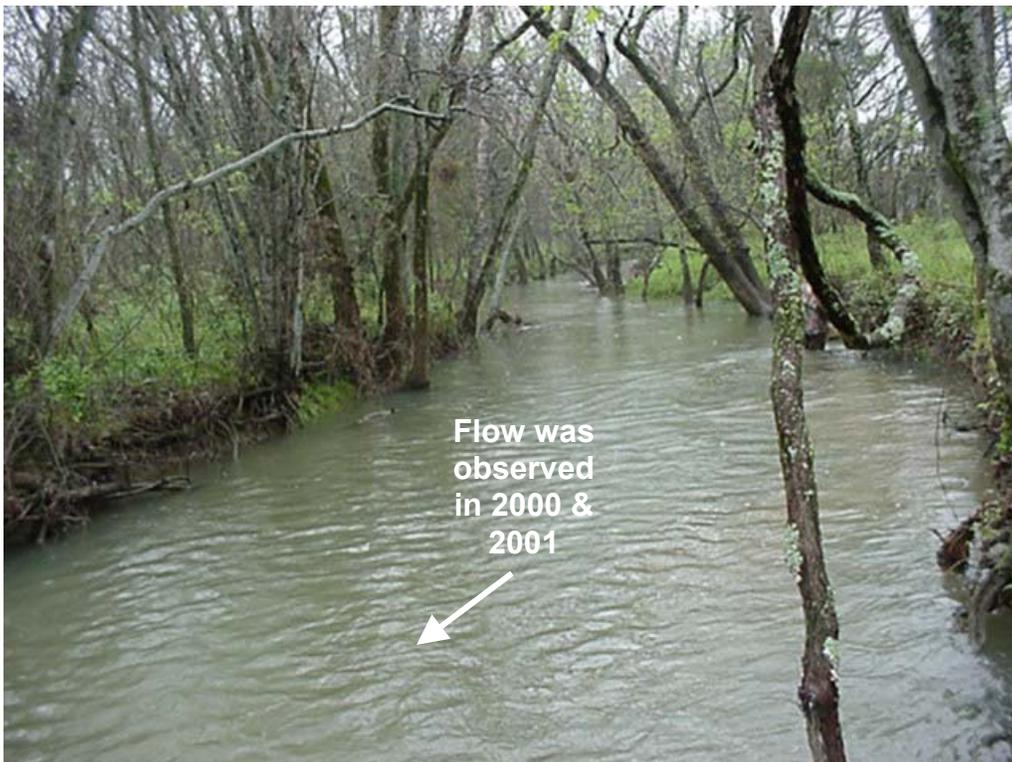
Figure D-46 Photo of Alexander Creek RM 0.4 - April 13, 2000

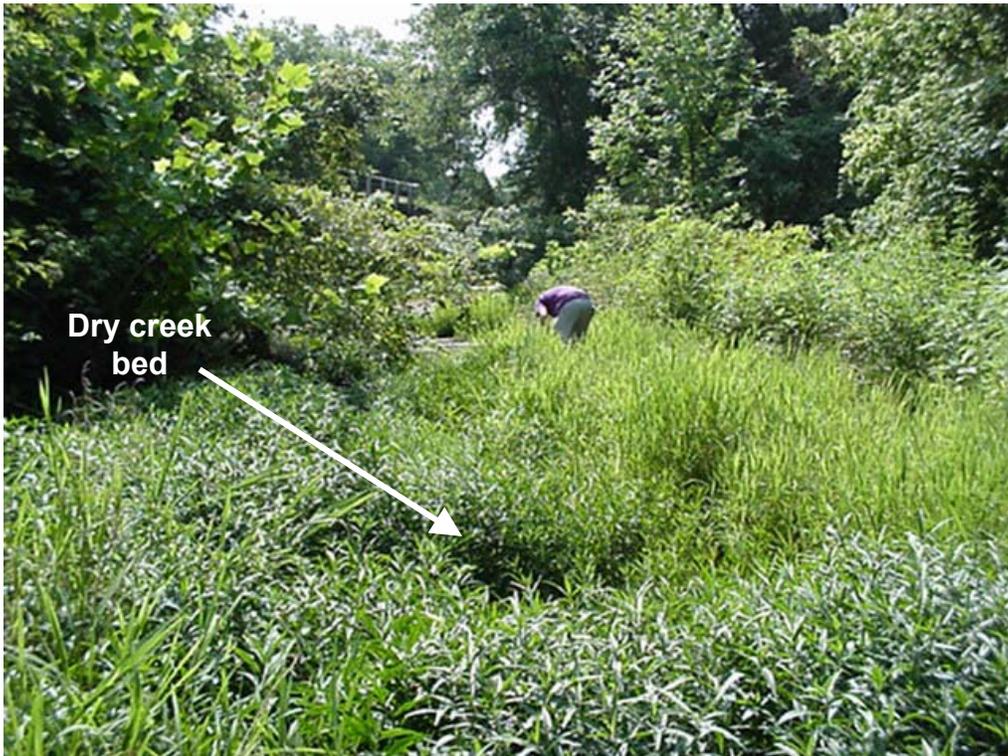
Figure D-51 Photo of Weakley Creek RM 5.2 Upstream - July 25, 2000

Weakley Creek was monitored at RM 5.2 by aquatic biologists from the State Lab on as a site of the probabilistic monitoring study. The stream was found dry on July 25, 2000 and October 17, 2000 (ref.: Figures D-51 through D-53). It contained flow on January 10, 2000, April 17, 2000, and again on May 8, 2001. All three sampling events noted moderate siltation. Land use upstream was mostly pasture with cattle.

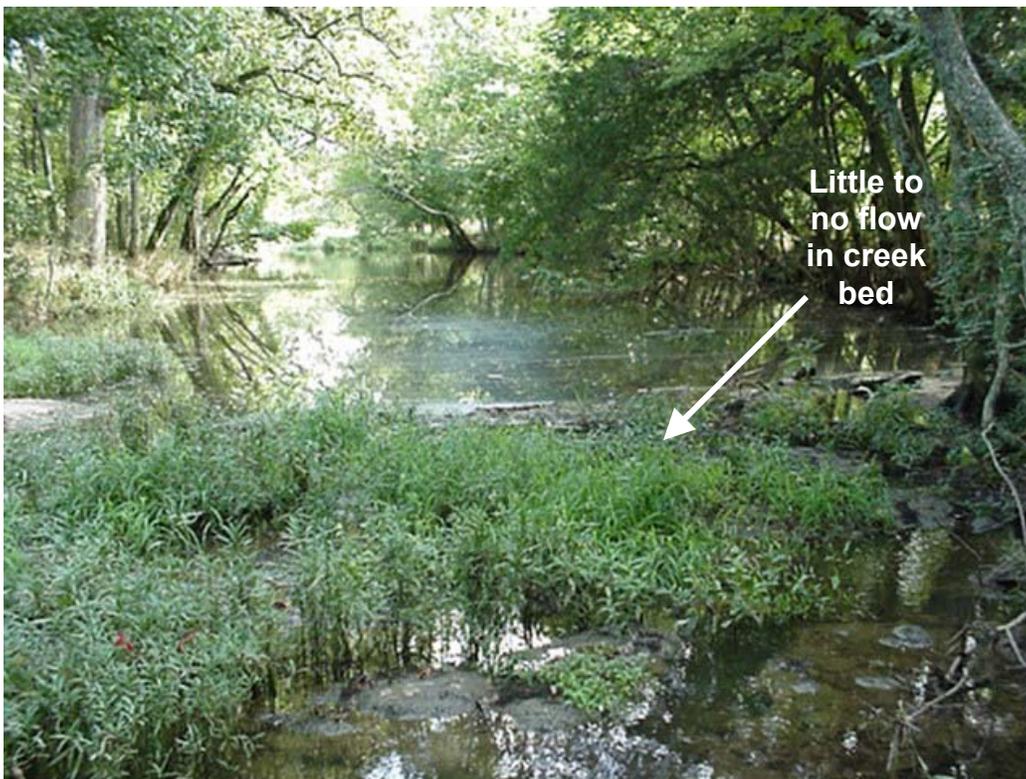
Figure D-54 Photo of Weakley Creek RM 1.7 Upstream - September 10, 2001

Weakley Creek was also monitored by aquatic biologists from the State Lab on September 10, 2001 at RM 1.7. A semiquantitative sample showed the macroinvertebrate community was rated as fully supporting. However, it was noted that the stream had very little flow with a fractured bedrock bottom. Water appeared to flow in and out of the deep fractures. The flow upstream of the site was ponded and slow moving (ref.: Figure D-54). The monitoring showed moderate silt and high turbidity.

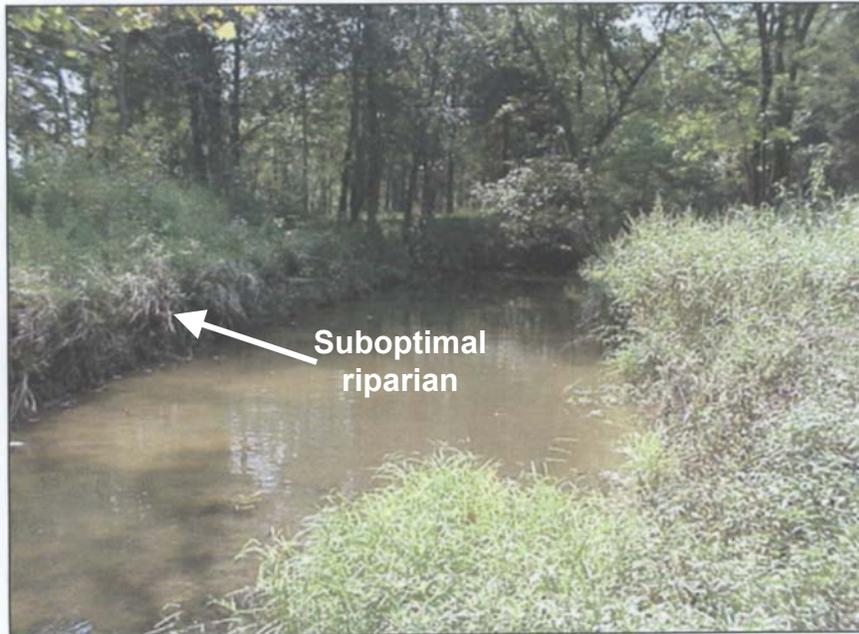
Figure D-63 Photo of Lick Creek - September 17, 2001

Lick Creek (LICK001.8ML) 200 d/s of Mt. Vernon Road.  
9/17/01 at 1030

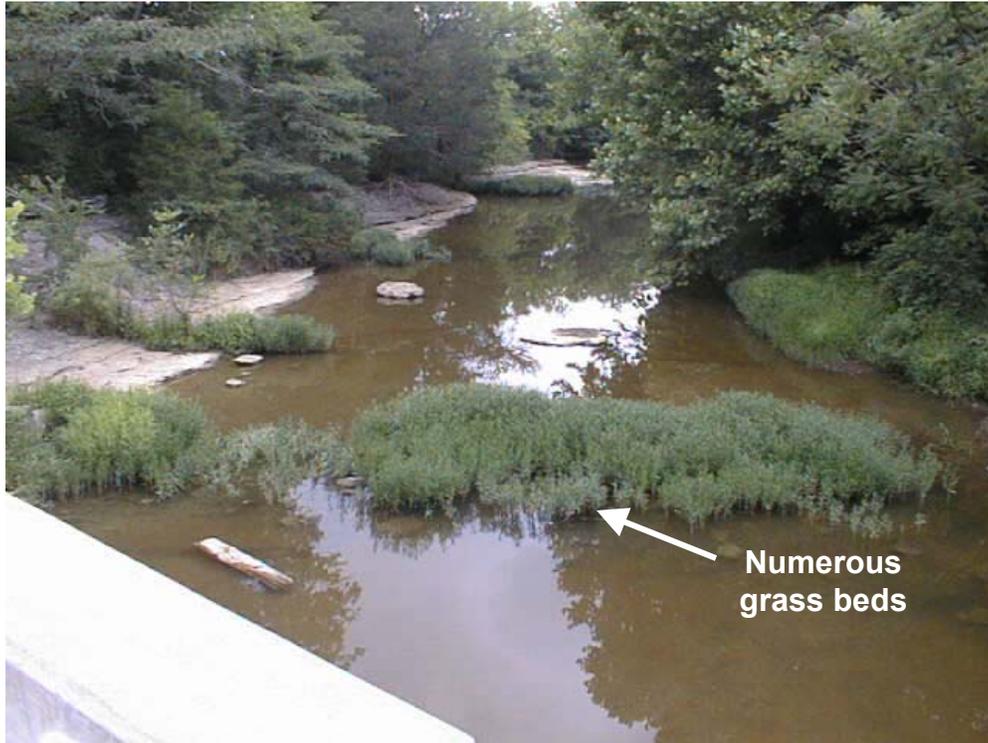
Figure D-66 Photo of Caney Creek RM 2.6 Upstream - July 9, 1999

Caney Creek was monitored in 1999 by the Nashville Environmental Field Office. A biorecon at RM 2.6 showed 5 EPT, 2 intolerant, and 20 total families. Notes report the presence of sediment deposits from the upper watershed. It was noted that there were new subdivision developments going in on the right bank downstream (ref.: Figure D-64). The stream was moderately turbid at this time giving the water a dark brown color (ref.: Figures D-65 through D-67).

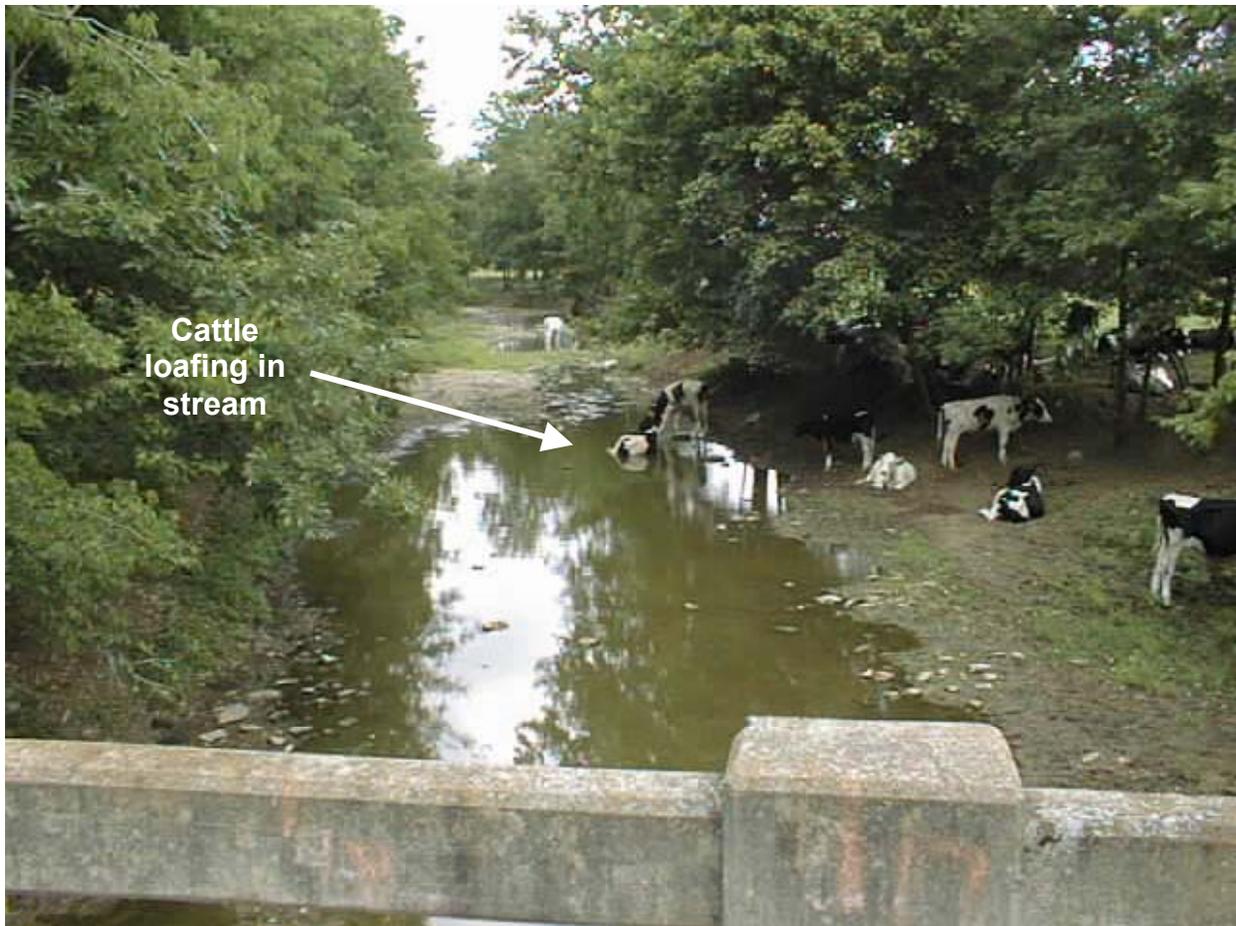
Figure D-69 Photo of Caney Creek RM 4.2 Upstream - July 9, 1999

The upper portions of the watershed were visited during the sampling period to look for possible sources of sediment (ref.: Figure D-68). Photographs of RM 4.2 showed heavy agricultural influence and a potential sediment source. The land use in the area was primarily pasture grazing. Stream banks were exposed and muddy with poor vegetation or cover. Cattle were observed loafing in the stream and along or on the stream banks. (ref.: Figures D-69 and D-70).

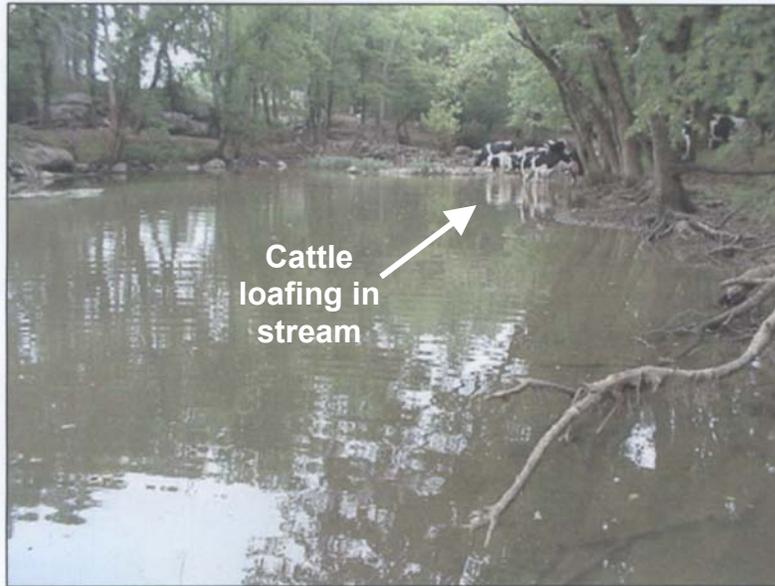
Figure D-82 Photo of East Rock Creek at RM 1.8 - July 24, 2004

East Rock Creek (EROCK001.8ML) 100 yards u/s  
Anes Station Rd. View upstream of the sample  
area. Col. KJS/CAP 7/24/04 @ 1403.
